Visual Assessment for Asbestos

Subject Property Address: [DELETED]
Date and time of Inspection: **18th July 2011 – 10:30 am**
Weather Conditions: **The weather was fine and dry at the time of the inspection.**
Description of Property: **The subject structure is a terraced dwelling estimated to have been constructed in late 1920's.**

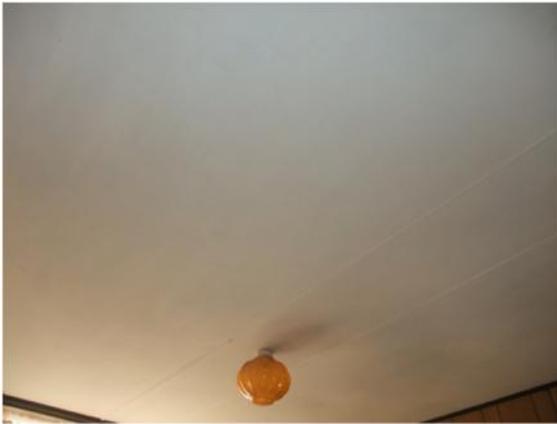
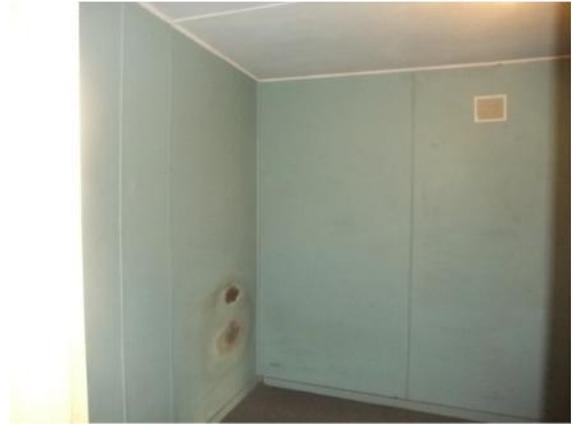
1. The bedrooms ceiling and wall linings. Approximately 28m² likely contained of Asbestos.

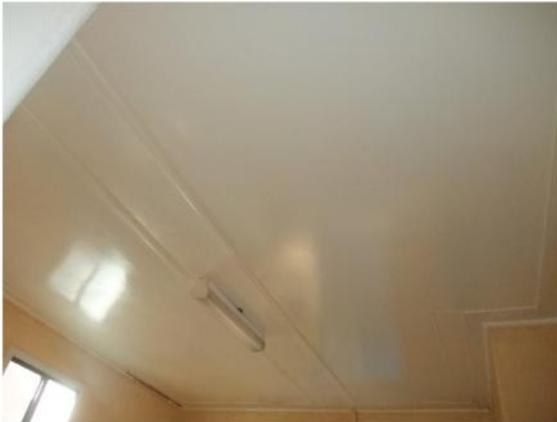
2. The Kitchen ceiling linings. Approximately 10m² likely contained of Asbestos.

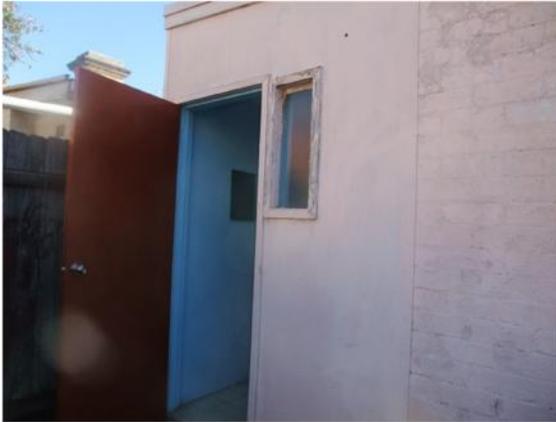
3. The external claddings at the rear. Approximately 2m² likely contained of Asbestos.

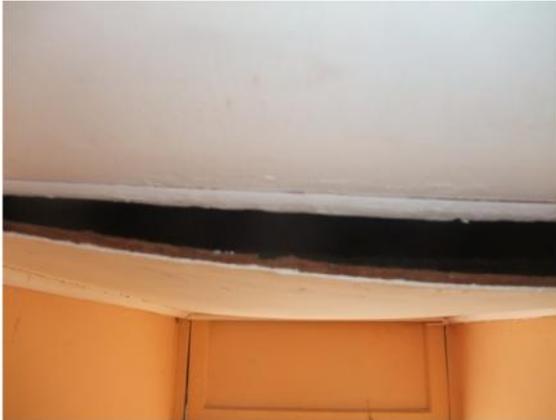
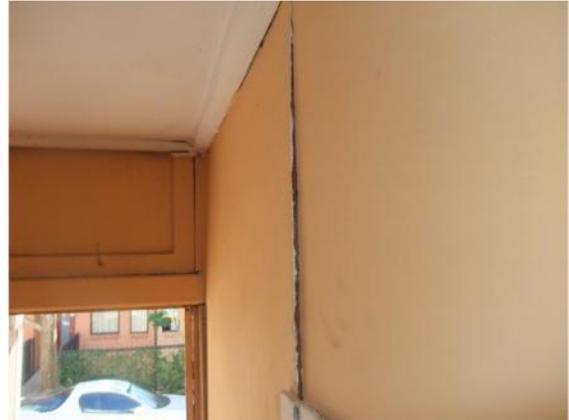
4. The Hallway wall and ceiling linings.

These areas does not appear to be Asbestos, the sheeting is more likely plywood material.

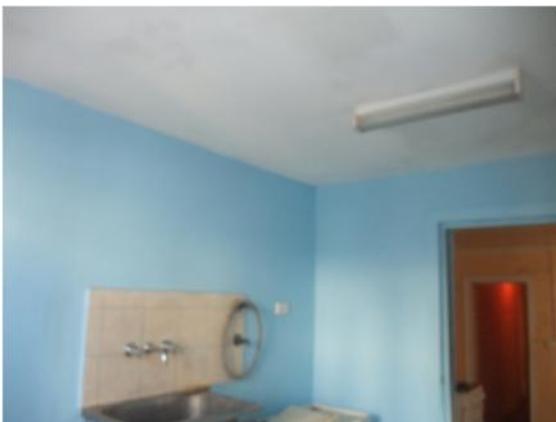
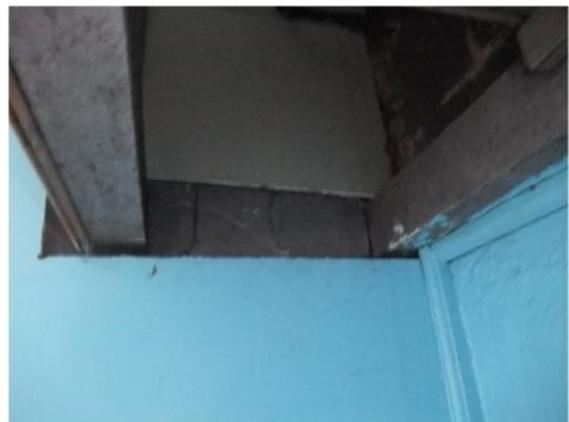
5. The Bathroom wall and ceiling linings.

These areas does not appear to be Asbestos, the sheeting is more likely gyprock material.
