Pre-Purchase Building Inspection Report

**22 Carrington St,
Seven Hills, NSW 2147**

Subject Property Address: 22 Carrington St, Seven Hills, NSW, 2147

Inspection Date and Time: 08-Jun-12 2:00:00 PM

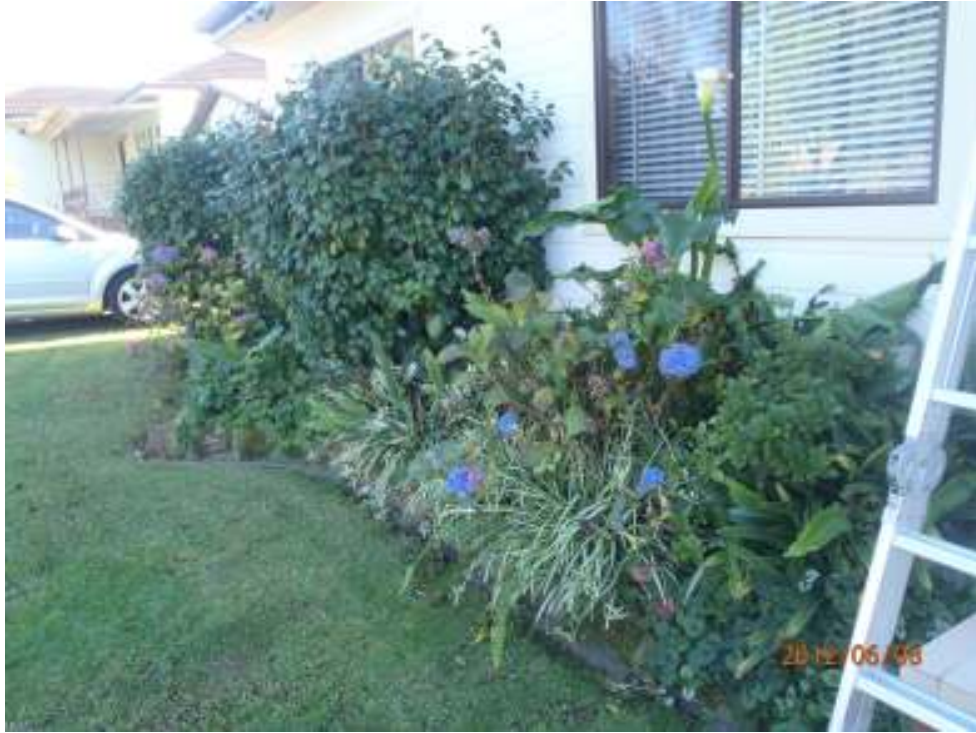
FRONT ENTRY/VERANDA

It is recommended to have the shrubs removed from the front of the property to prevent termite entry.

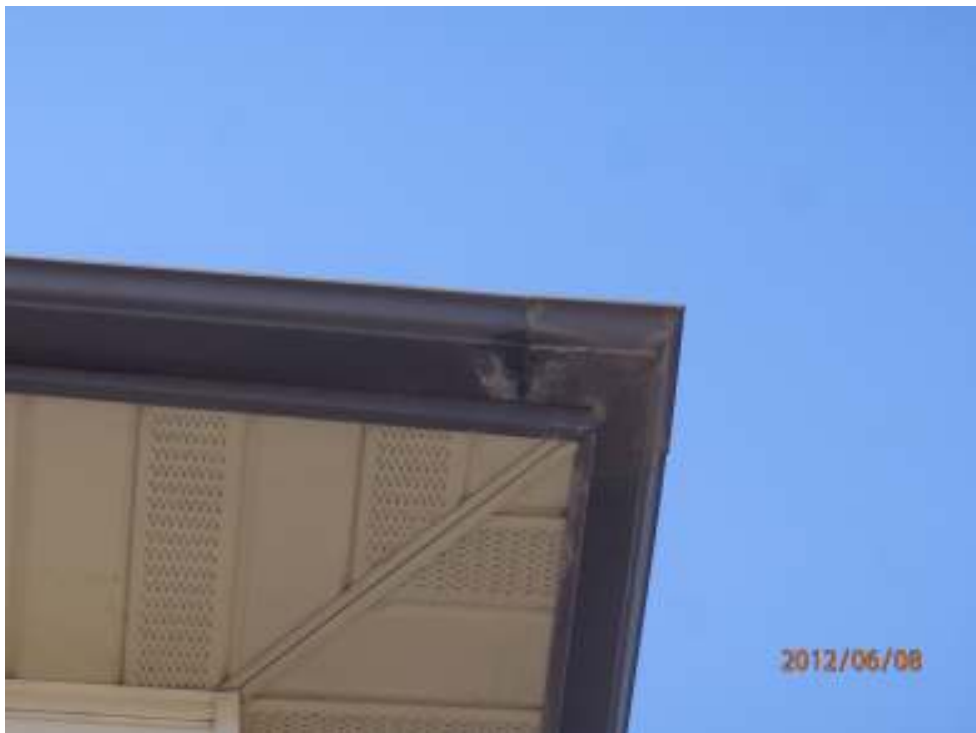
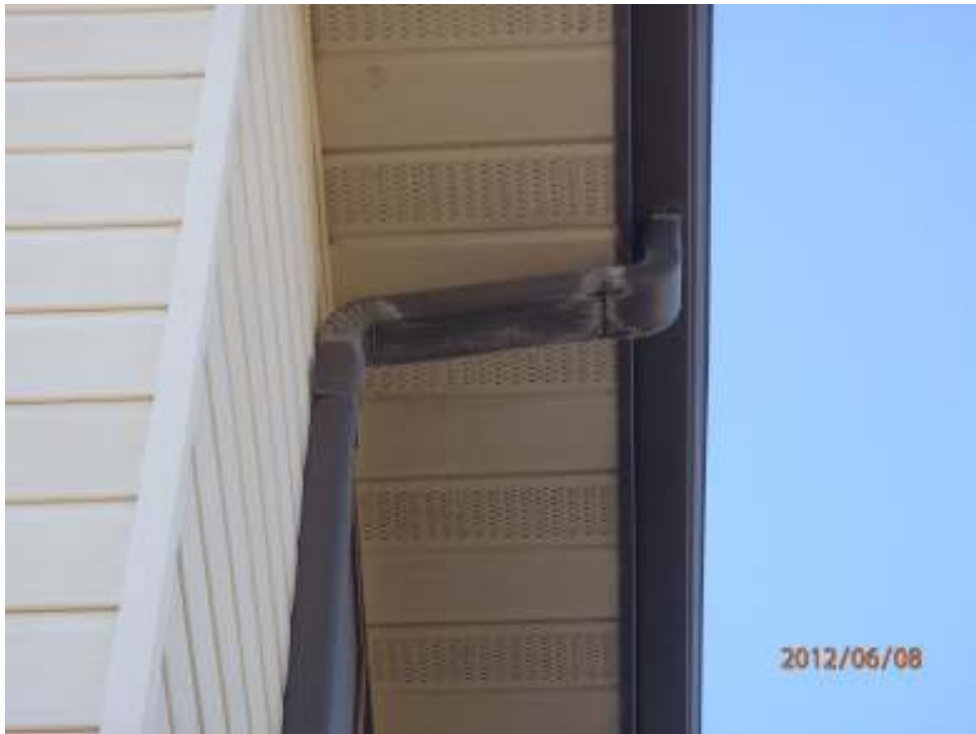
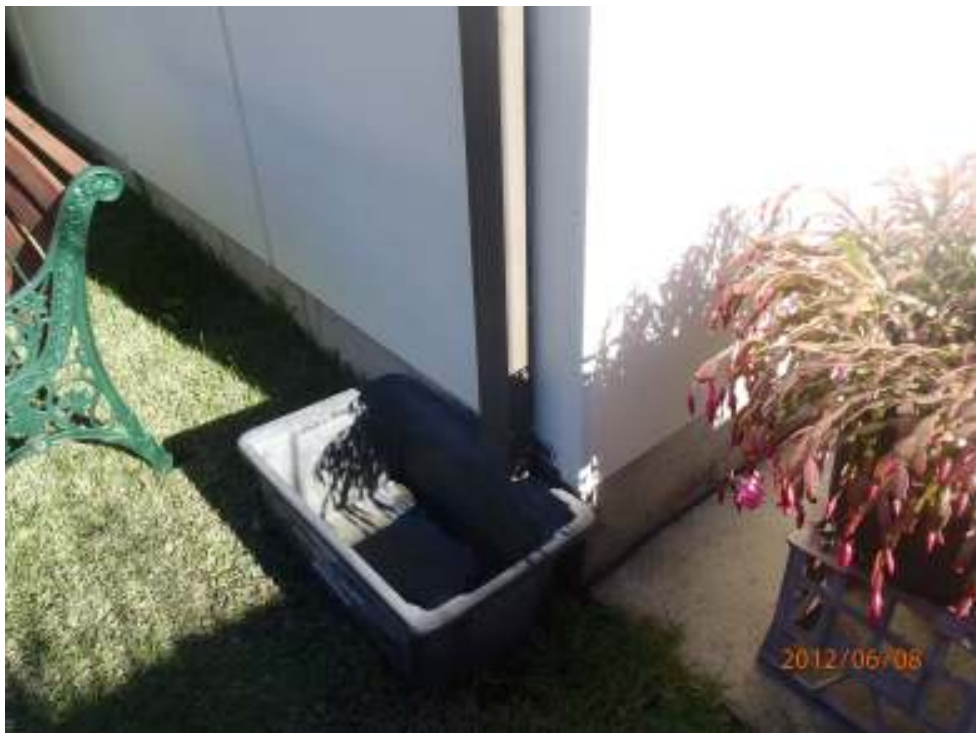
GUTTERS AND DOWNPIPES

Evident signs of deterioration were sighted to the downpipes and gutters.

Painting is recommended in order to help prolong the life expectancy of the downpipes and gutters.

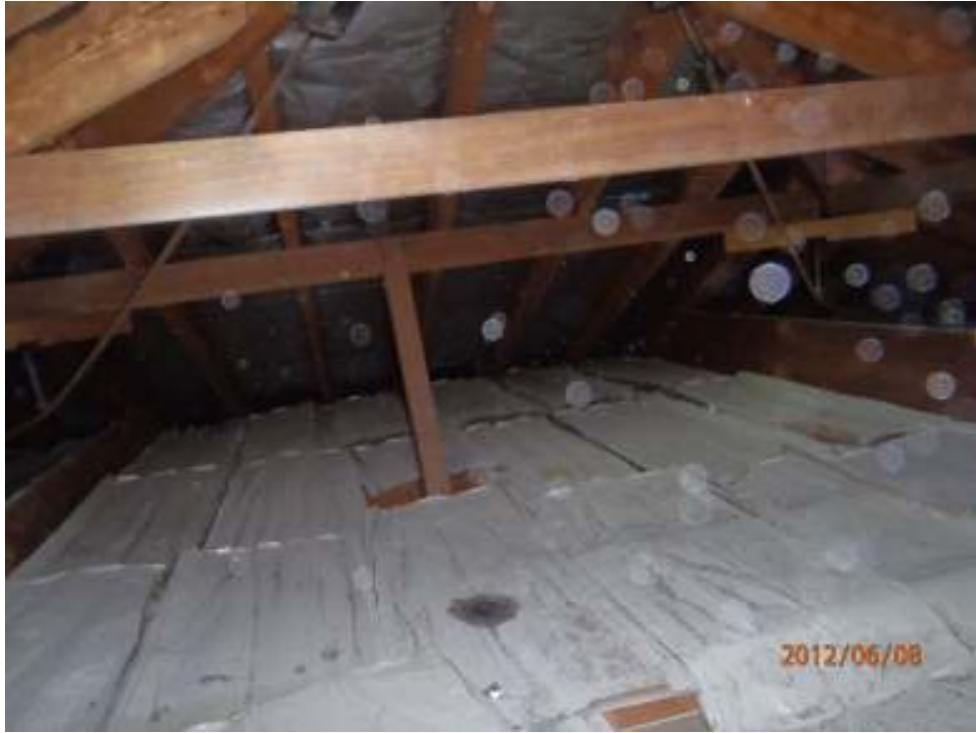
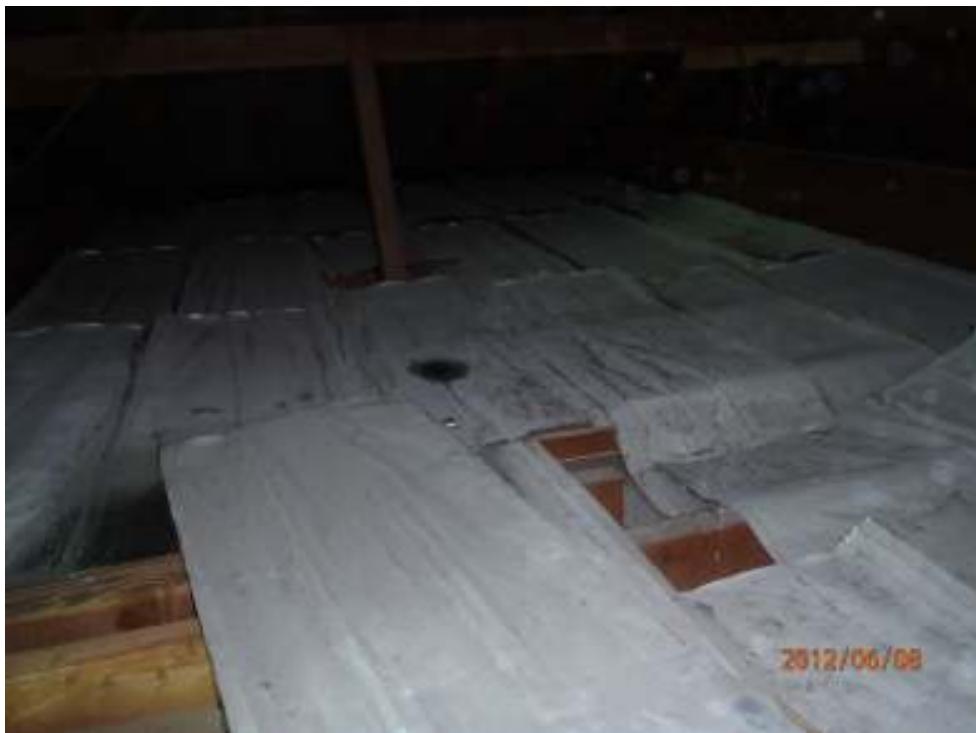
INTERNAL ROOF CAVITY

Overall Condition: SAFETY

Evident Foil sighted within the roof space. It is recommended to be removed as this is a fire hazard.

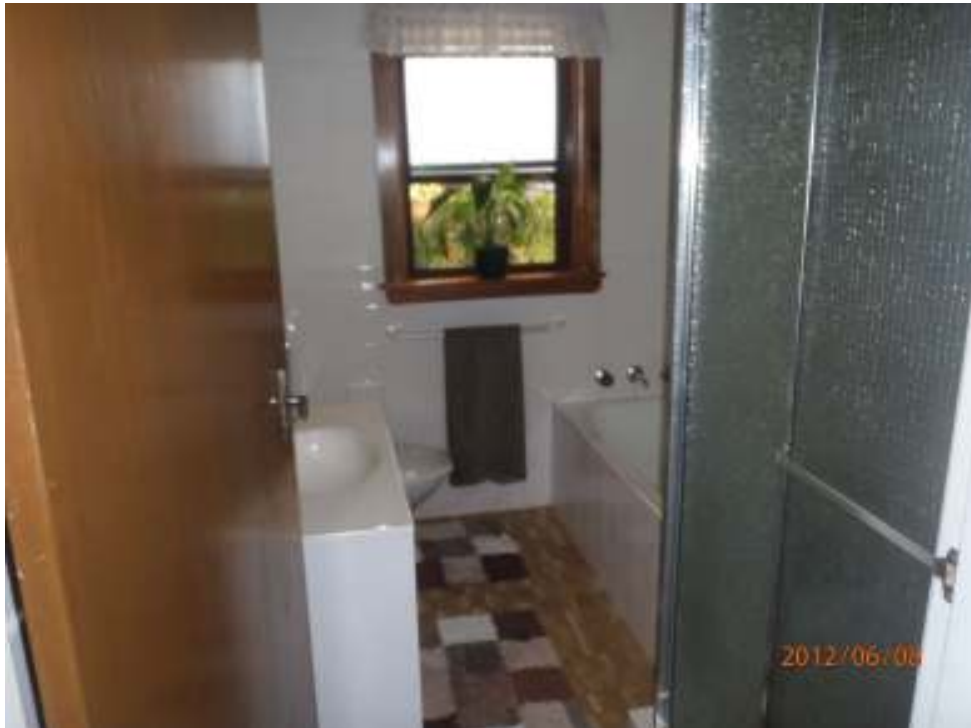
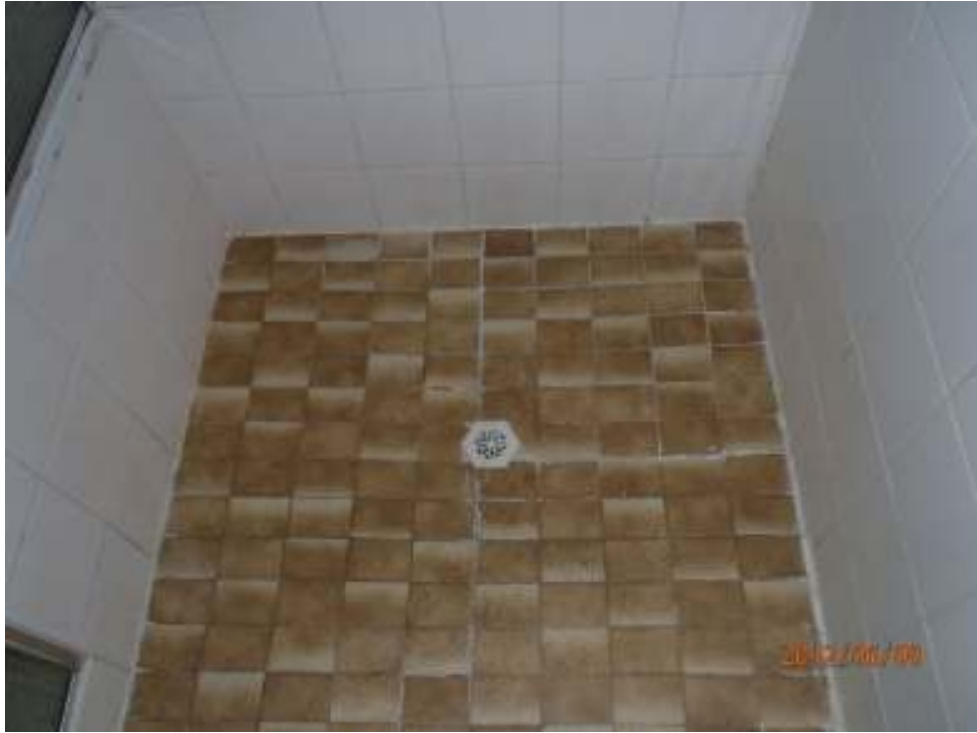
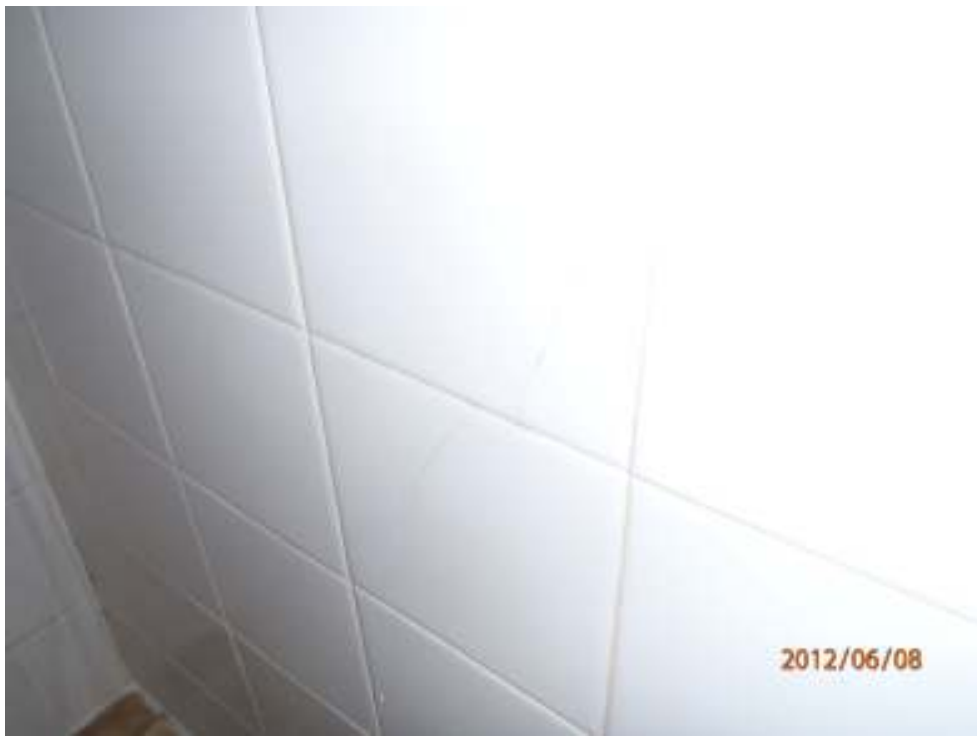
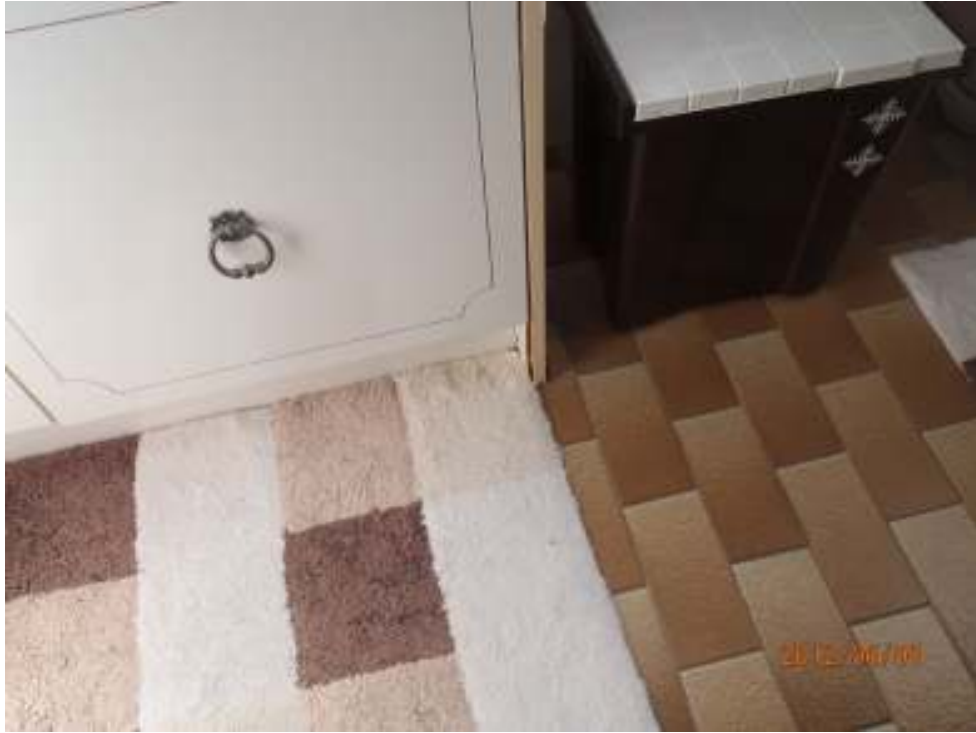
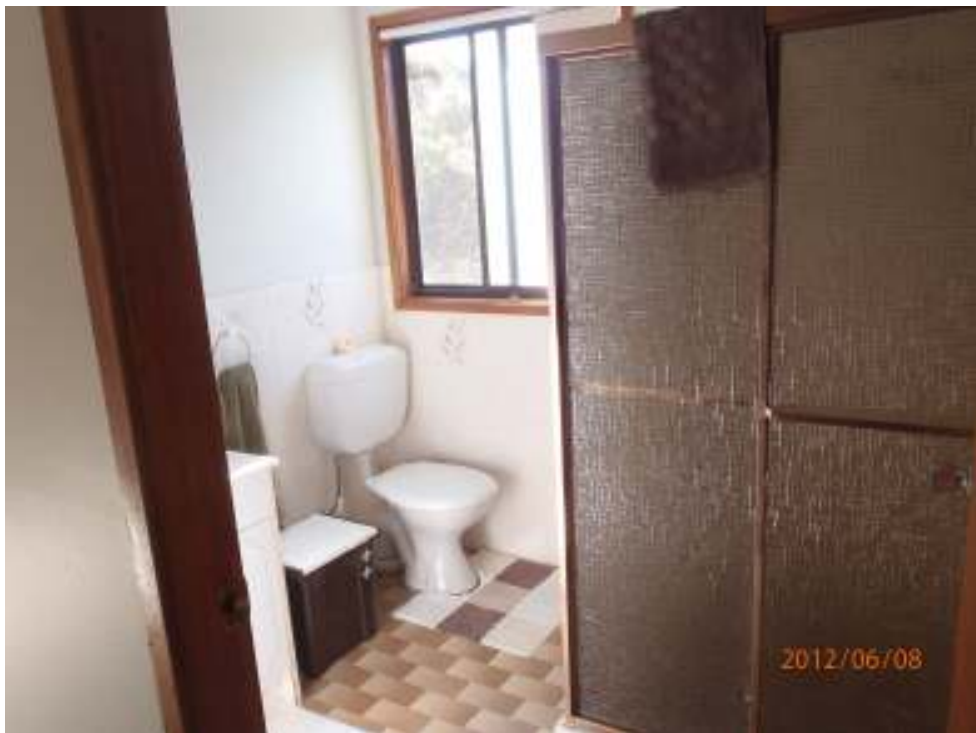
BATHROOMS AND TOILETS

Evident crack sighted to the ground floor bathroom shower. It is recommended to be fixed.

Evident efflorescence sighted to the tiles in the ground floor bathroom shower area. It is recommended tiles are re-sealed to prevent water leakage and high moisture metre readings.

Evident deterioration sighted to the first floor bathroom vanity cupboard. Maintenance is required to prolong life expectancy.

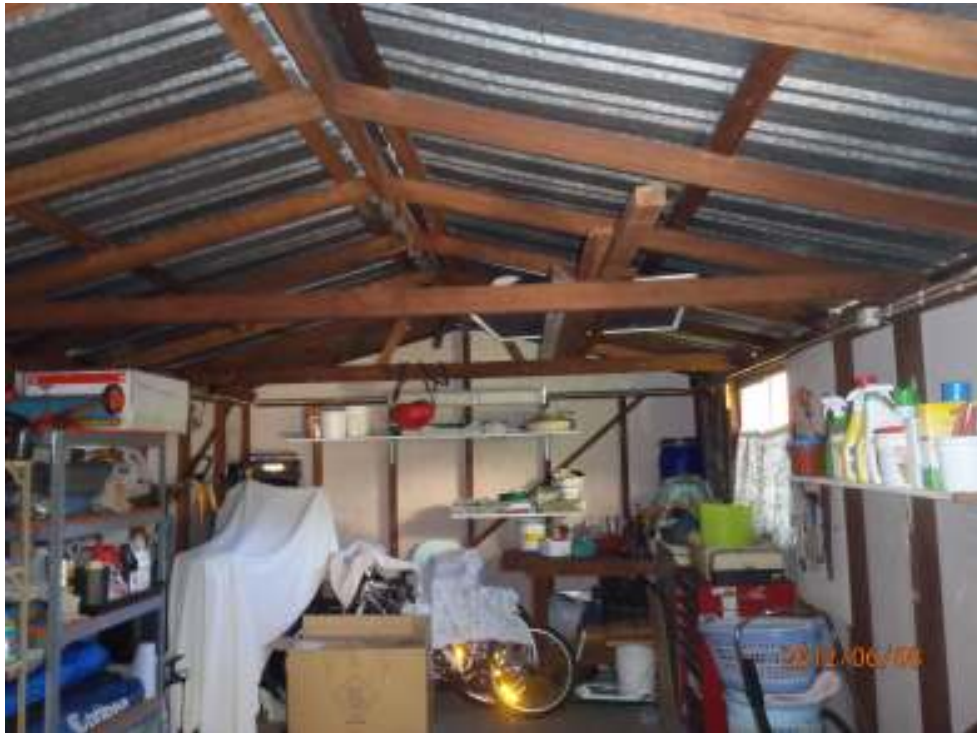
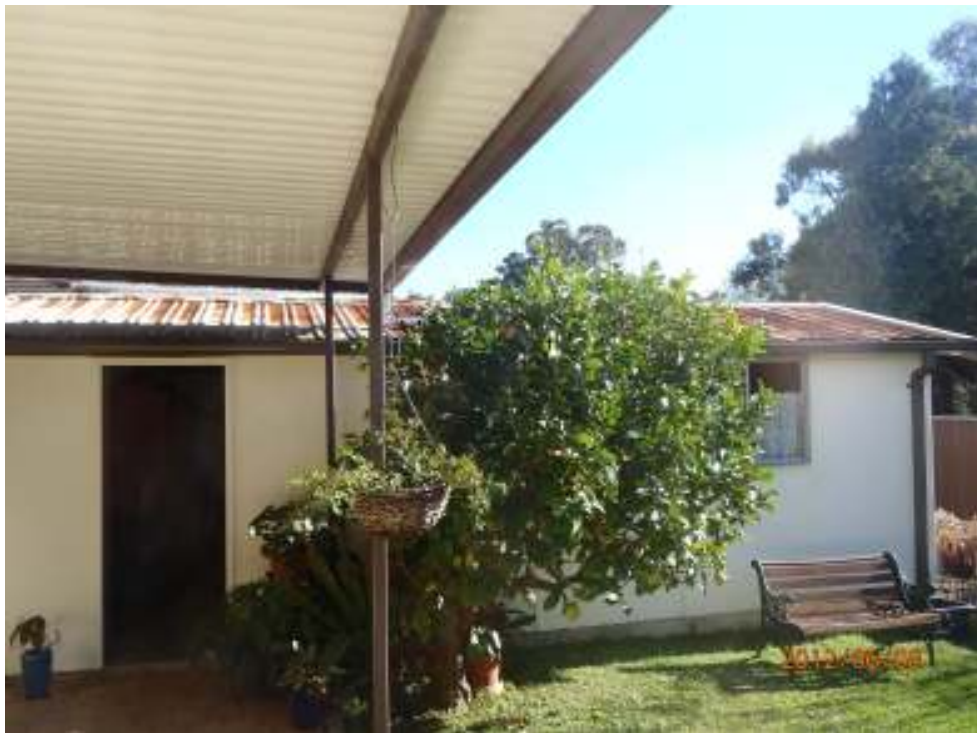
GARAGE/CARPORT

Evident rust is sighted to the garage roofing sheets. It is recommended to be painted to prolong its life expectancy.

All downpipes should be connected adequately; currently the garage downpipe is not correctly connected.

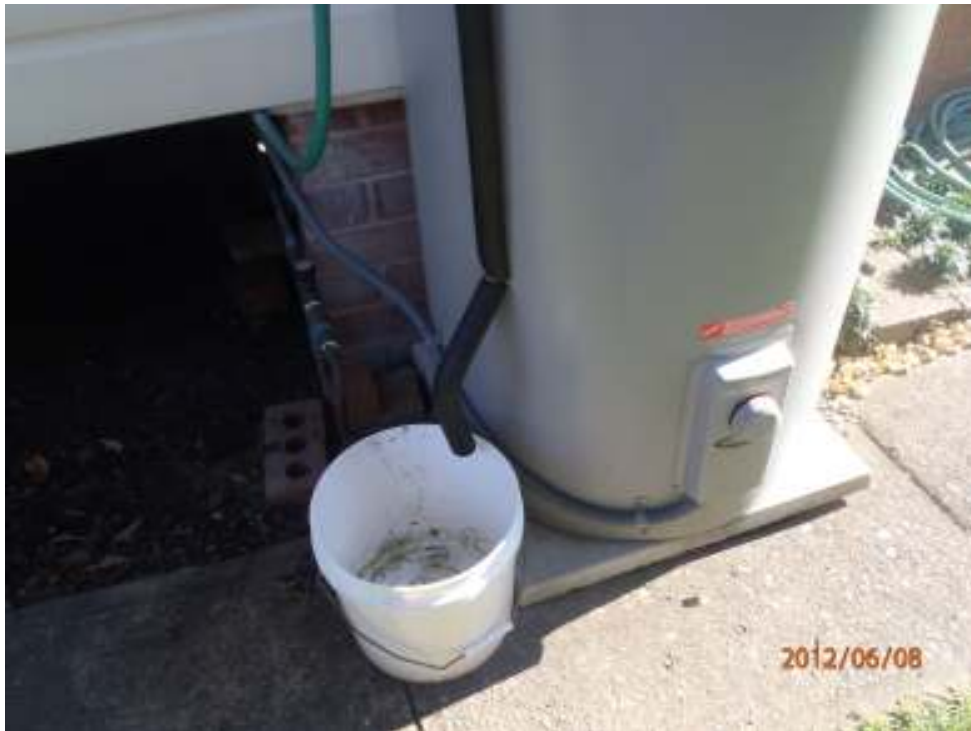
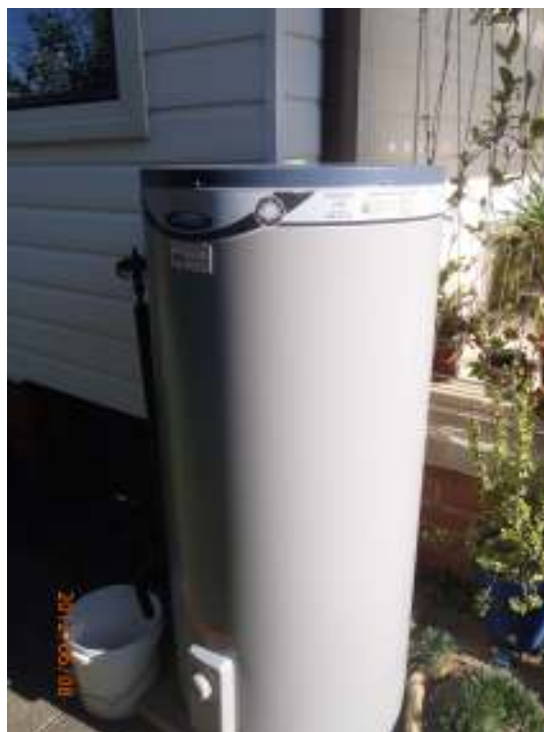
HOT WATER SERVICE

The over flow pipe should be connected to the water system or at least 1m away from the property.
