Timber Pest Inspection Report

22 Carrington St, Seven Hills, NSW 2147

Inspection Date and Time: 08-Jun-12 2:00:00 PM

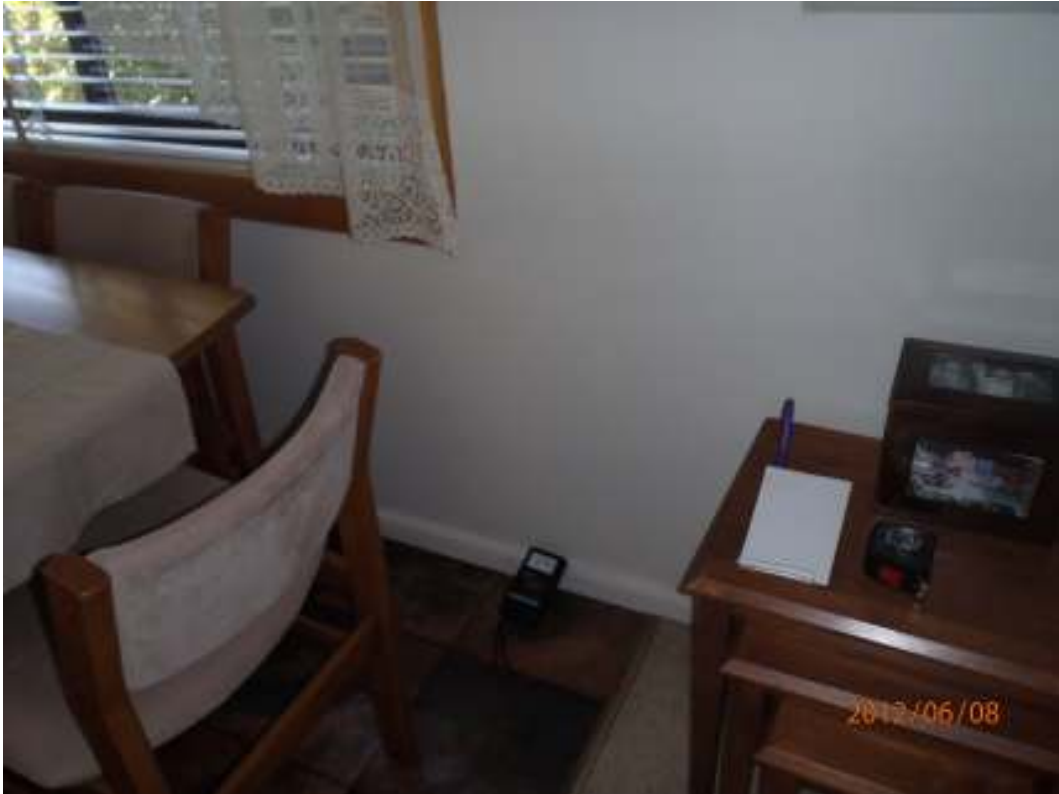
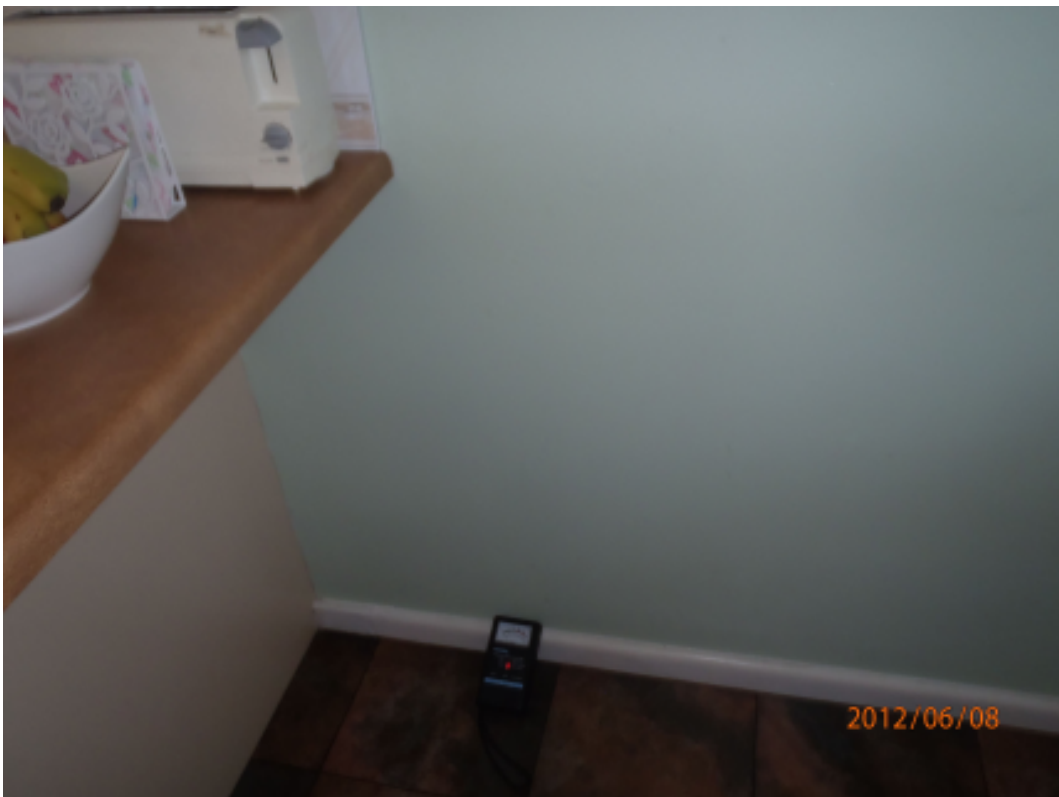
Photos for Undetected Termite Risk Assessment

The termite risk is moderate to high due to excess moisture in the sub floor area and high moisture metre readings detected in various areas of the property.

It is recommended a Aggline drainage system is installed to the front and side of the property to prevent water entry to the sub floor area and the detection of high moisture metre readings..

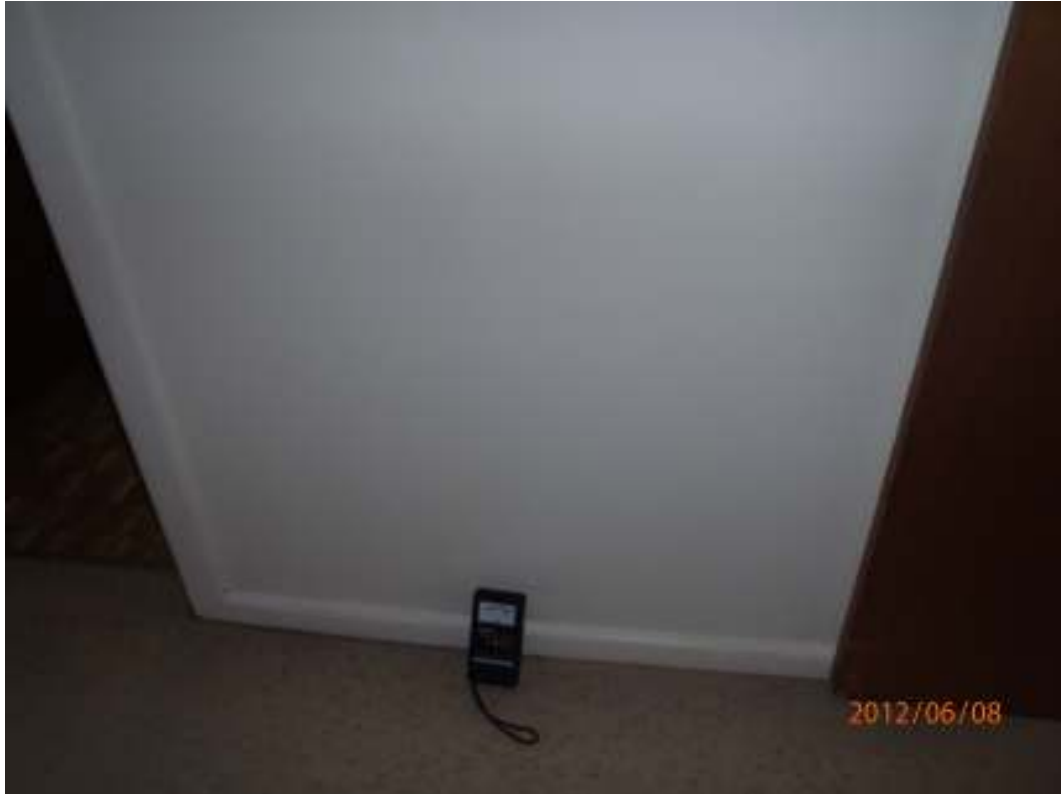
Photos for Presence of Excessive Moisture

Evident excessive moisture sighted within the sub floor area due to lack of drainage.

Evident high moisture meter readings was detected in various areas of the property. It is recommended a Aggline drainage system is installed and water leaks are fixed.
