Thermal Timber Pest Inspection Report

40 Burdekin Cr, St Ives, NSW 2075

Inspection Date and Time: 07-Jun-12 1:00:00 PM

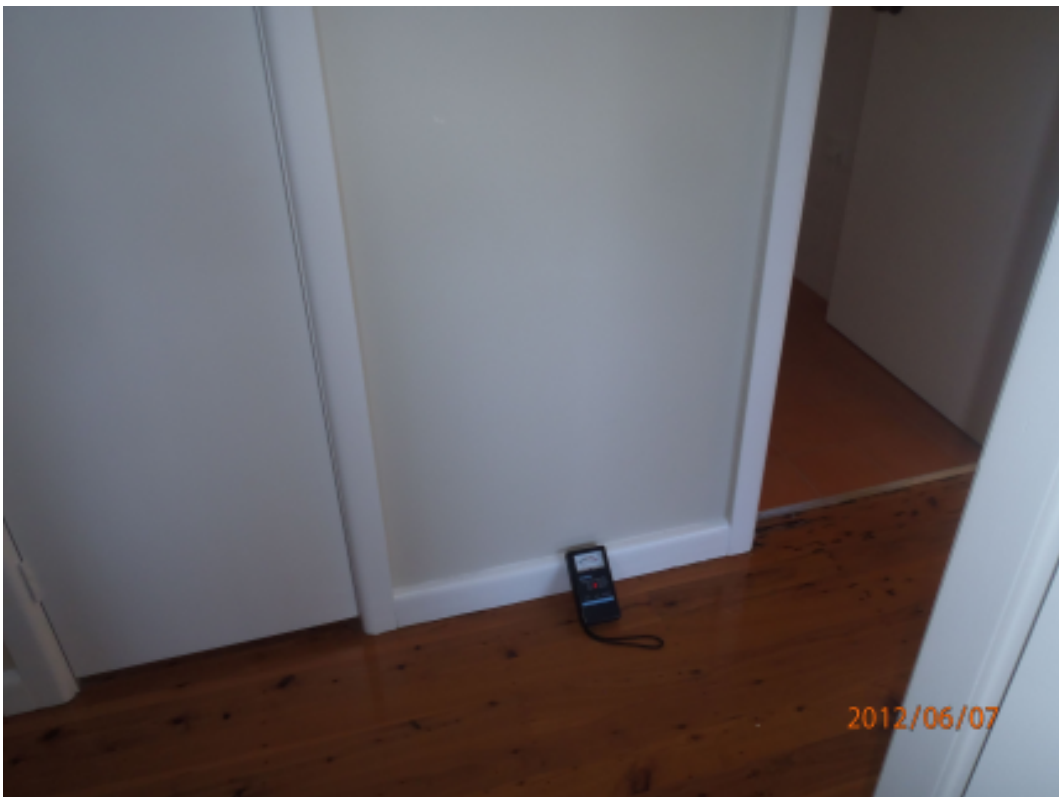
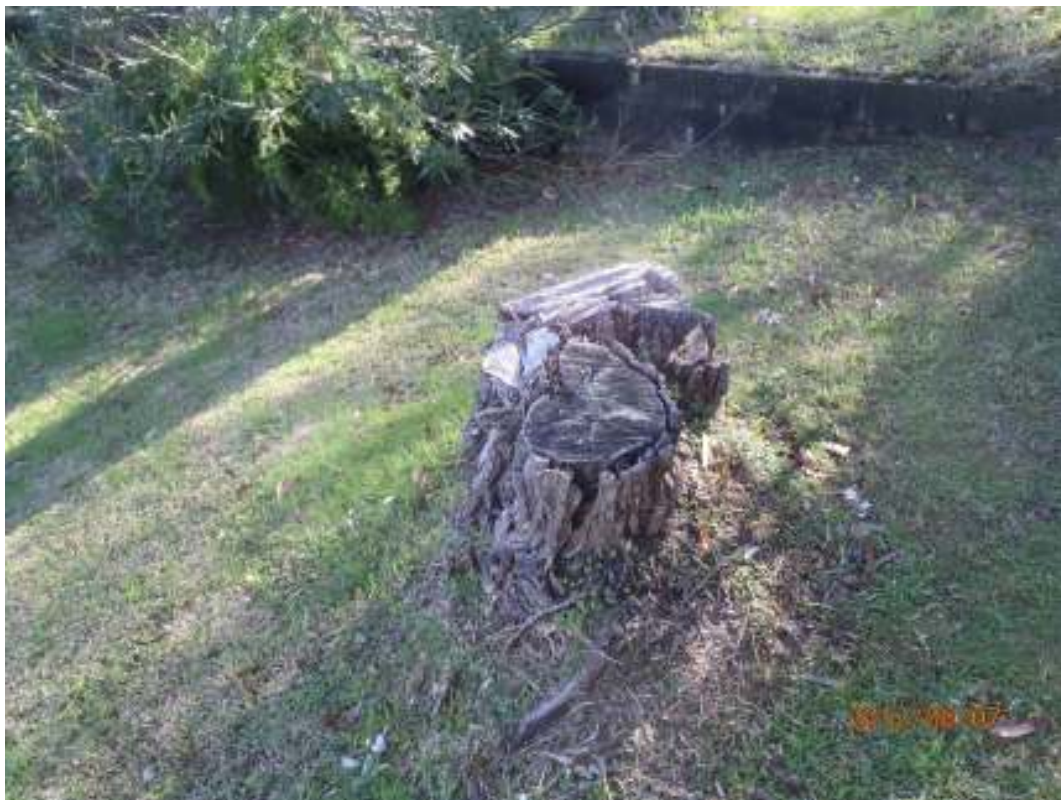
Photos for Undetected Termite Risk Assessment

The termite risk is high due to high moisture metre readings detected through out the property and evident termite tracking sighted within 10 metres of the property.

It is recommended a Aggline drainage system is installed around the property and a spoon drain is put in place.

A termite barrier management system is also recommended to prevent a termite attack.
It is recommended tree stump is removed as it is a excellent food source for termites.
