Building Defects Inspection Report

[ADDRESS DELETED]

Subject Property Address: **[SAMPLE]**
Date and time of Inspection: **[SAMPLE]**
Weather Conditions: **The weather was fine at the time of the inspection. There had not been rain in the preceding week.**
Description of Property: **The property is a 1 bedroom unit with an external balcony in a complex of multi units. The dwelling is brand new.**

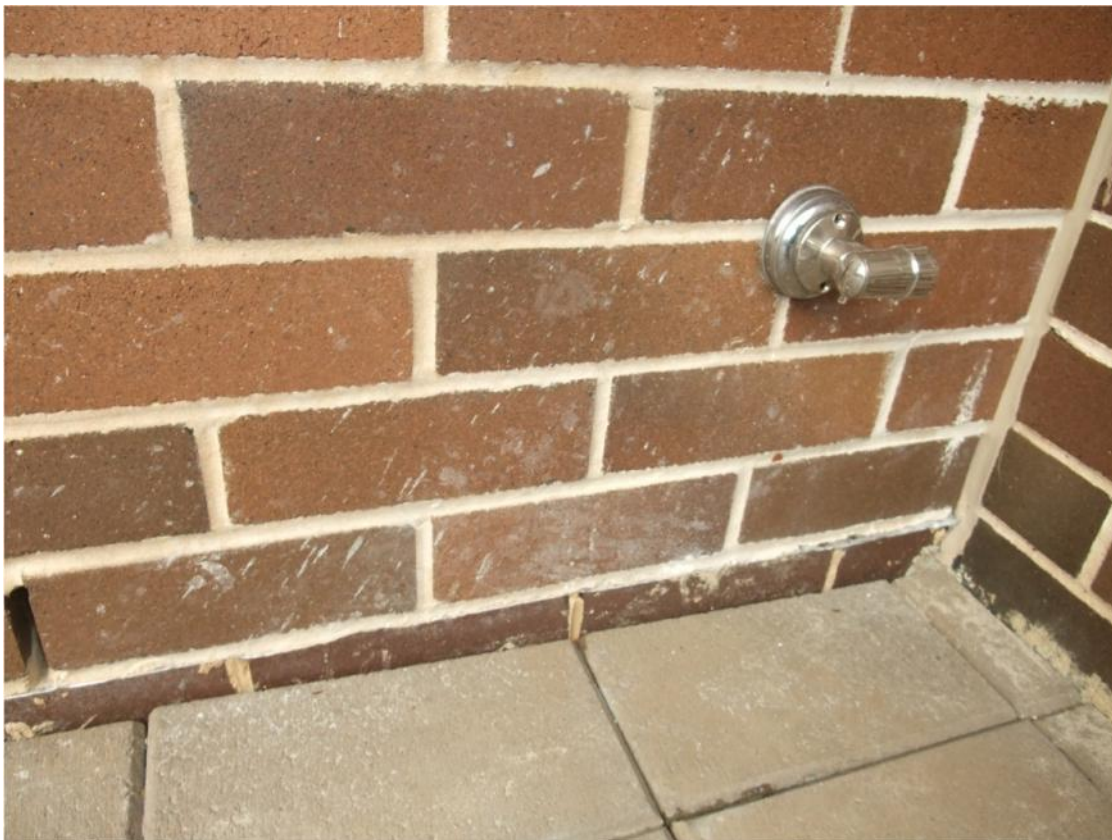
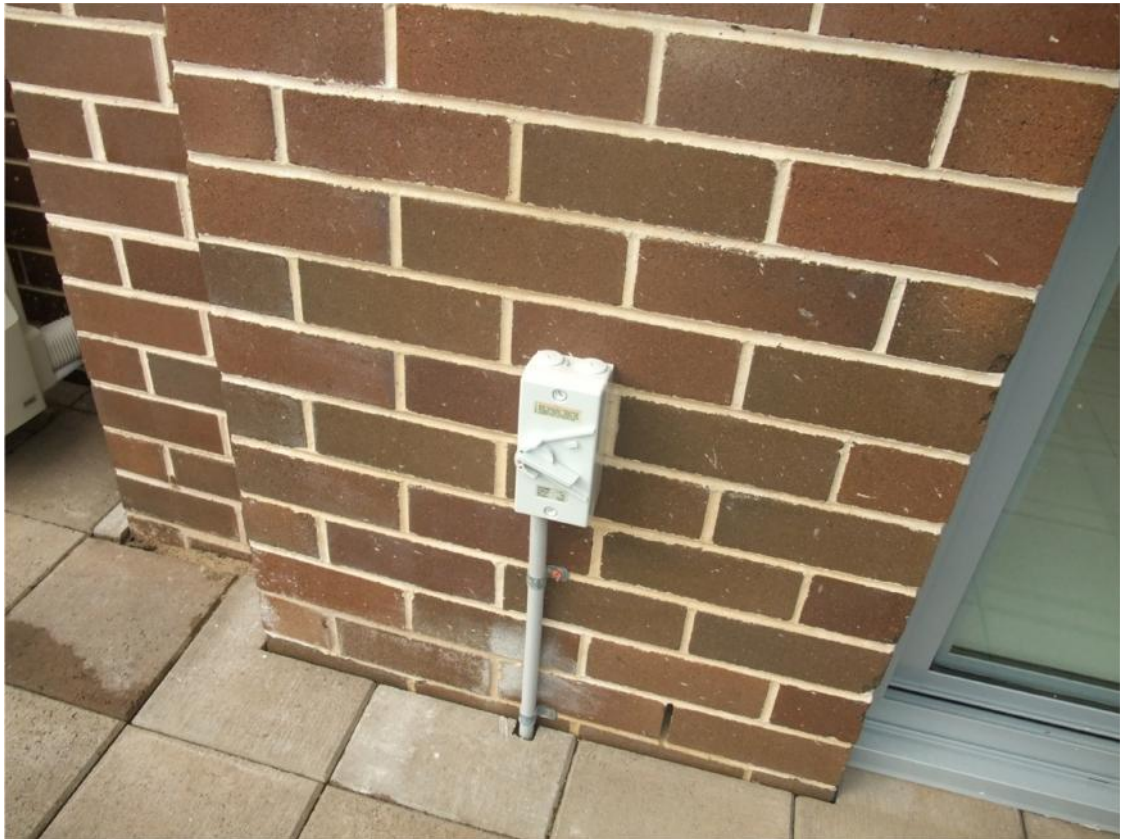
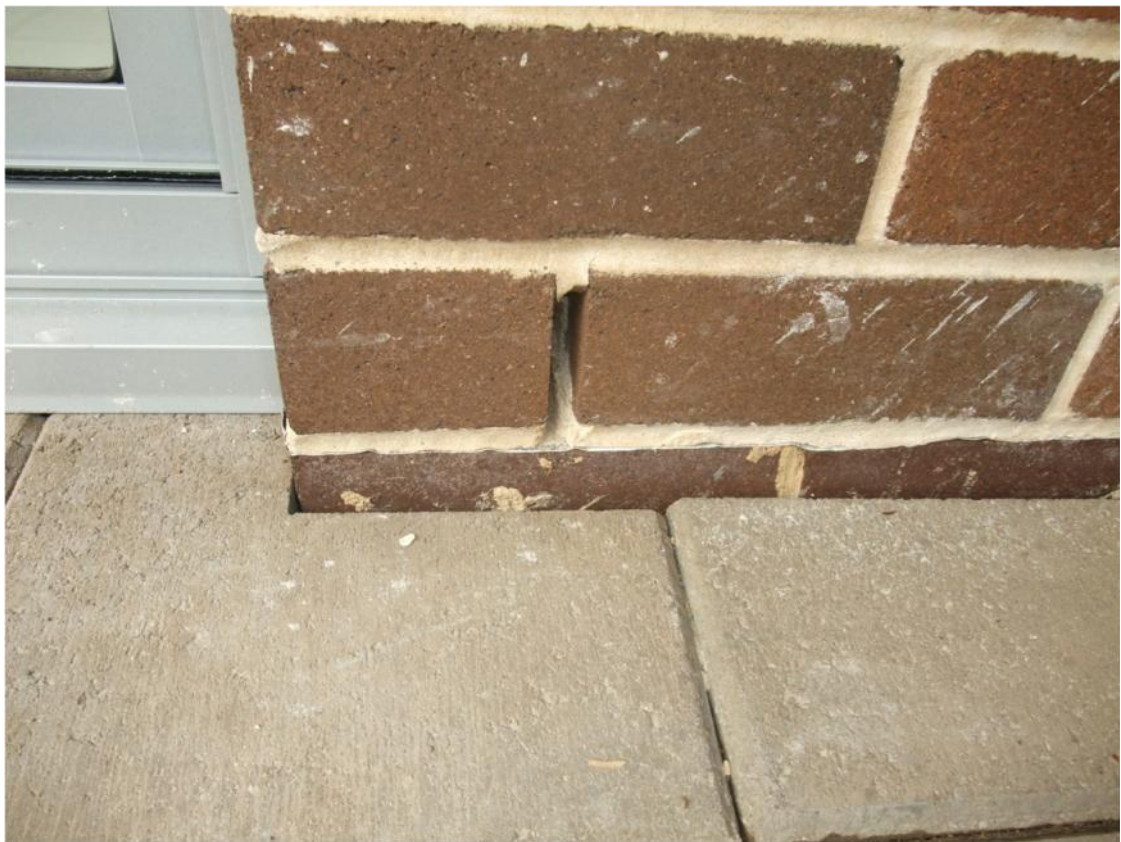
Overall Condition: Acceptable.

Brickwork requires cleaning.

Re-pointing mortars joints.

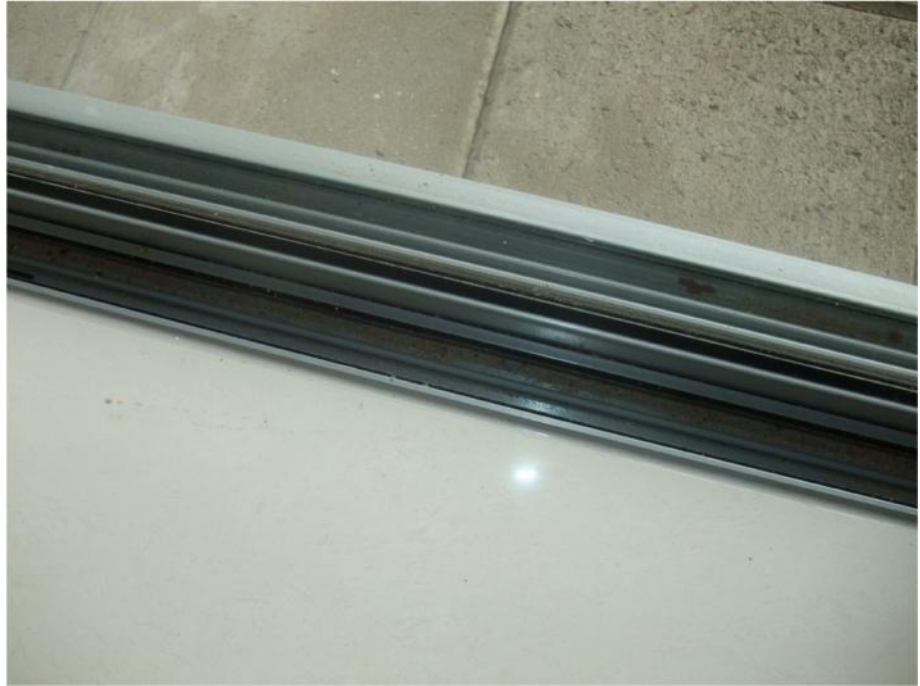
Sliding door track
requires cleaning.

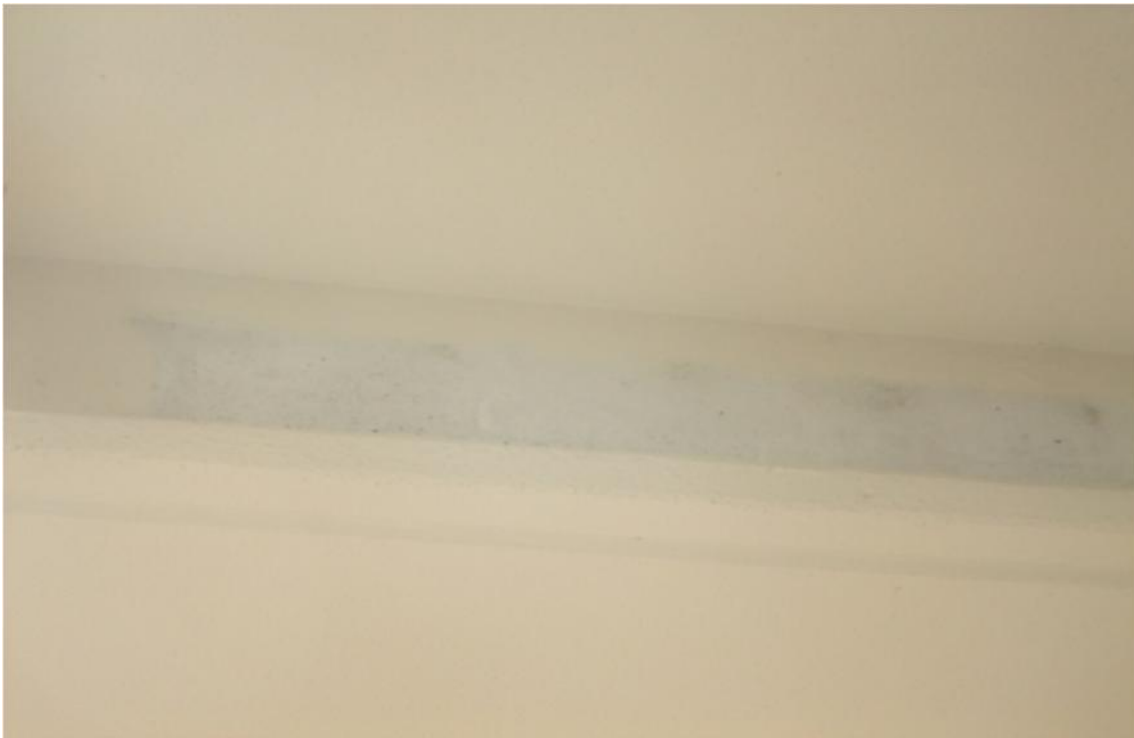
A section to balcony ceiling is incomplete paint work, requires re-painting.

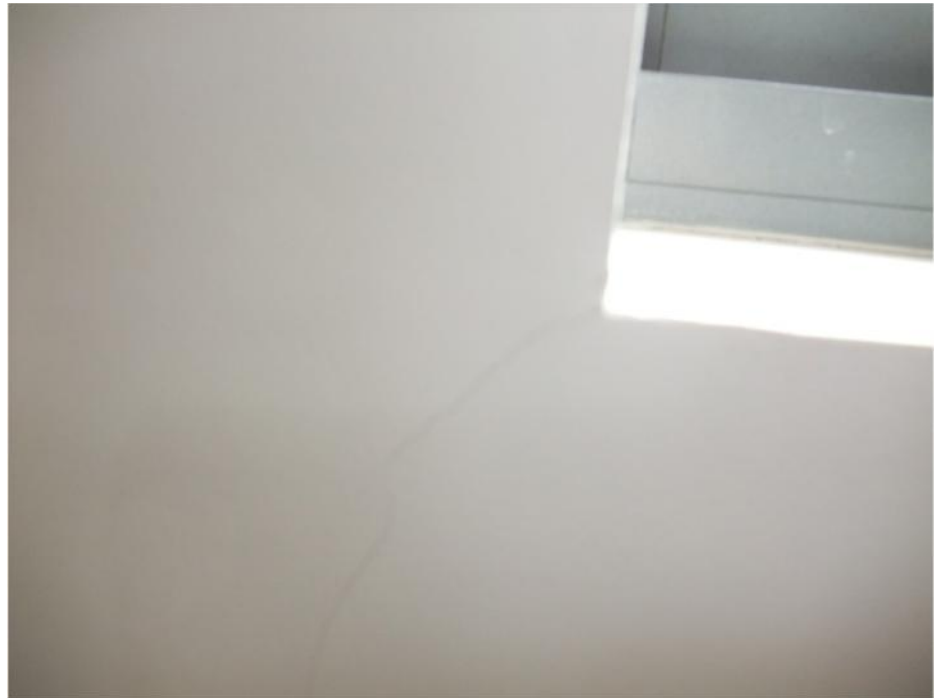
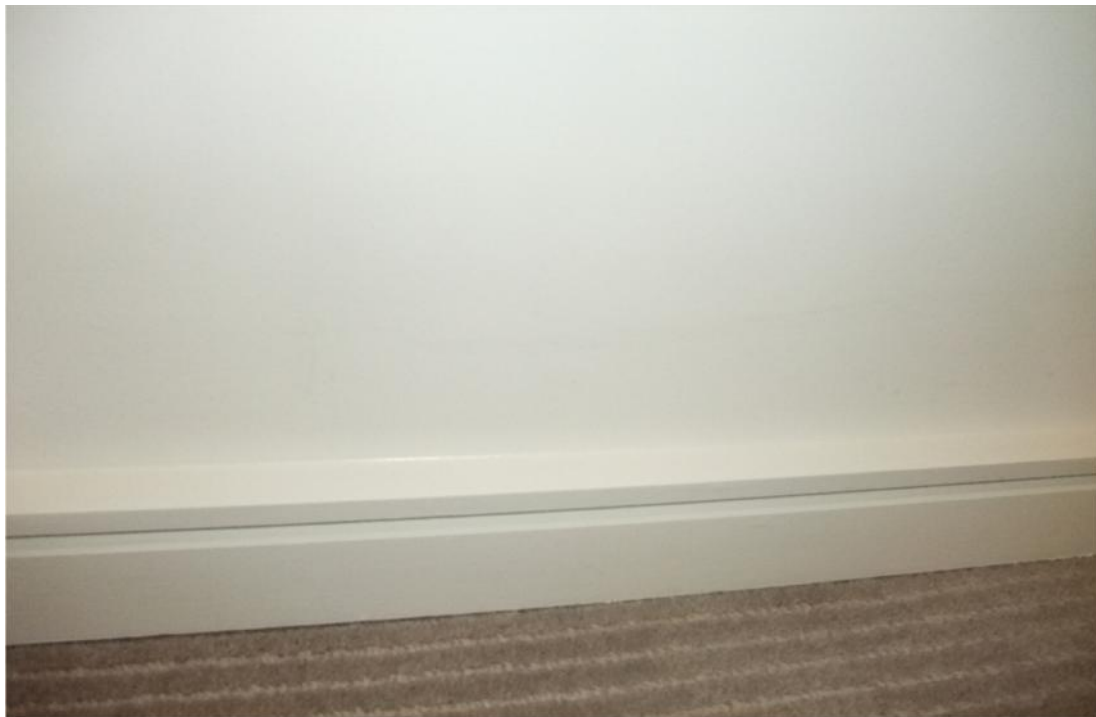
Overall Condition: Fair.
Fine cracks on wall lining under the window in the Bedroom.
Minor scratch marks are located near the bottom of the wall in the Study room.

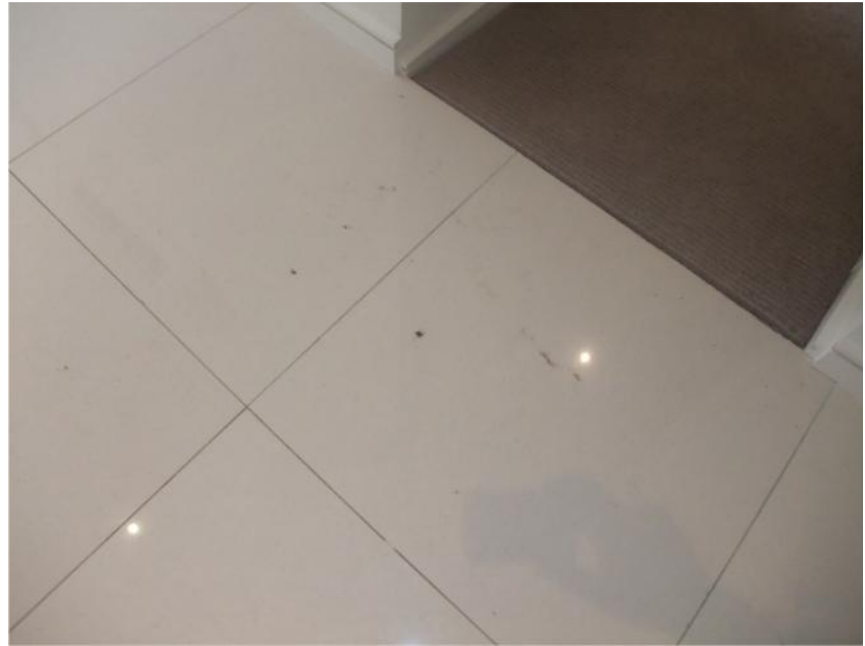
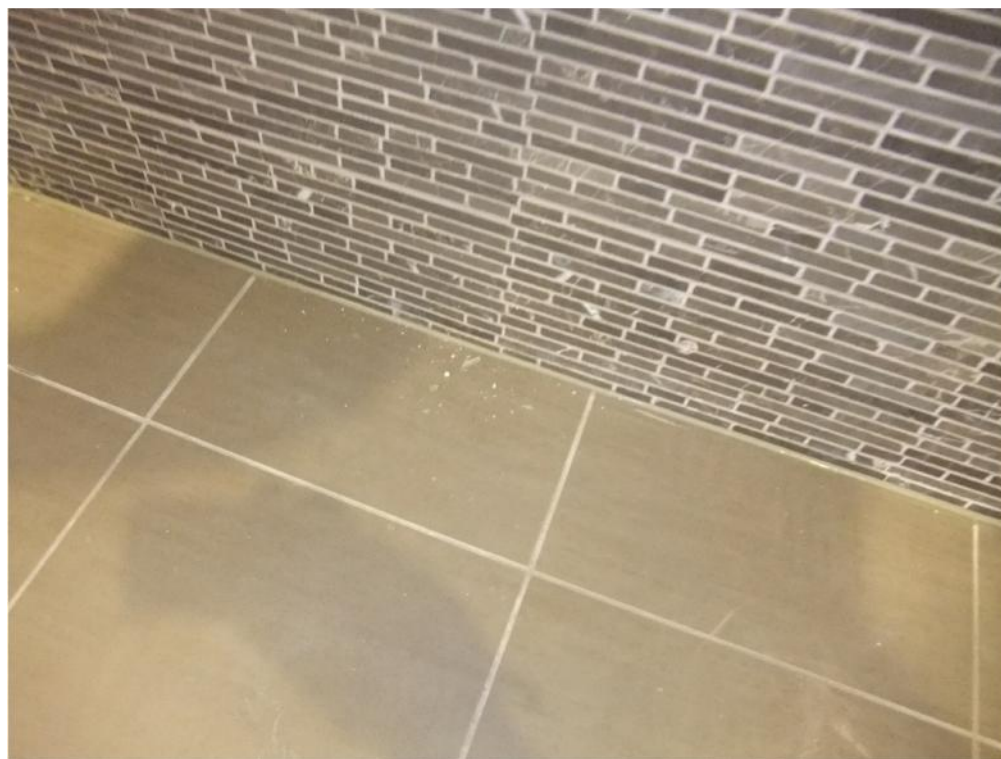
Floor tiles to needs to be cleaned.

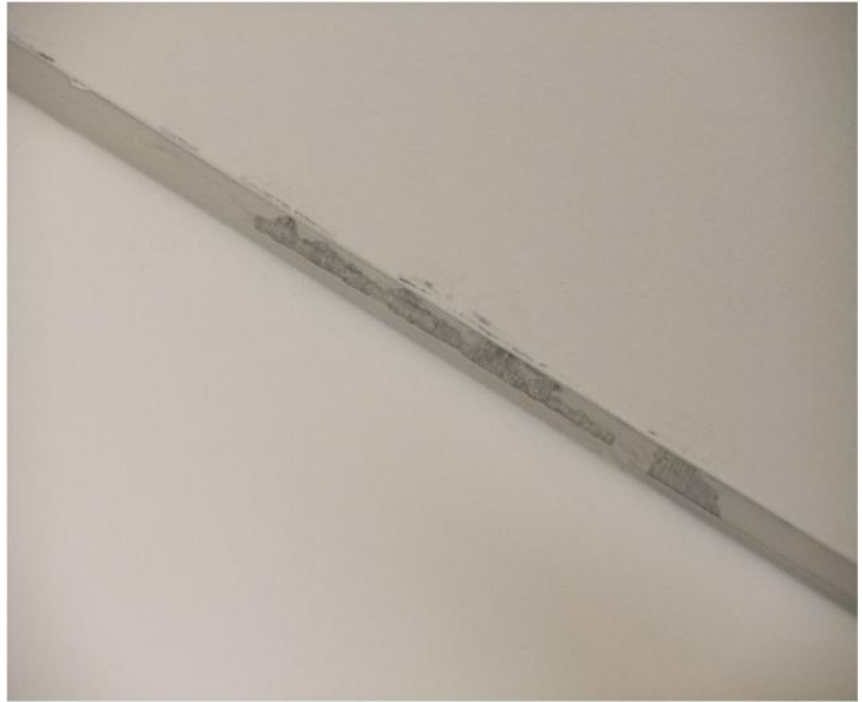
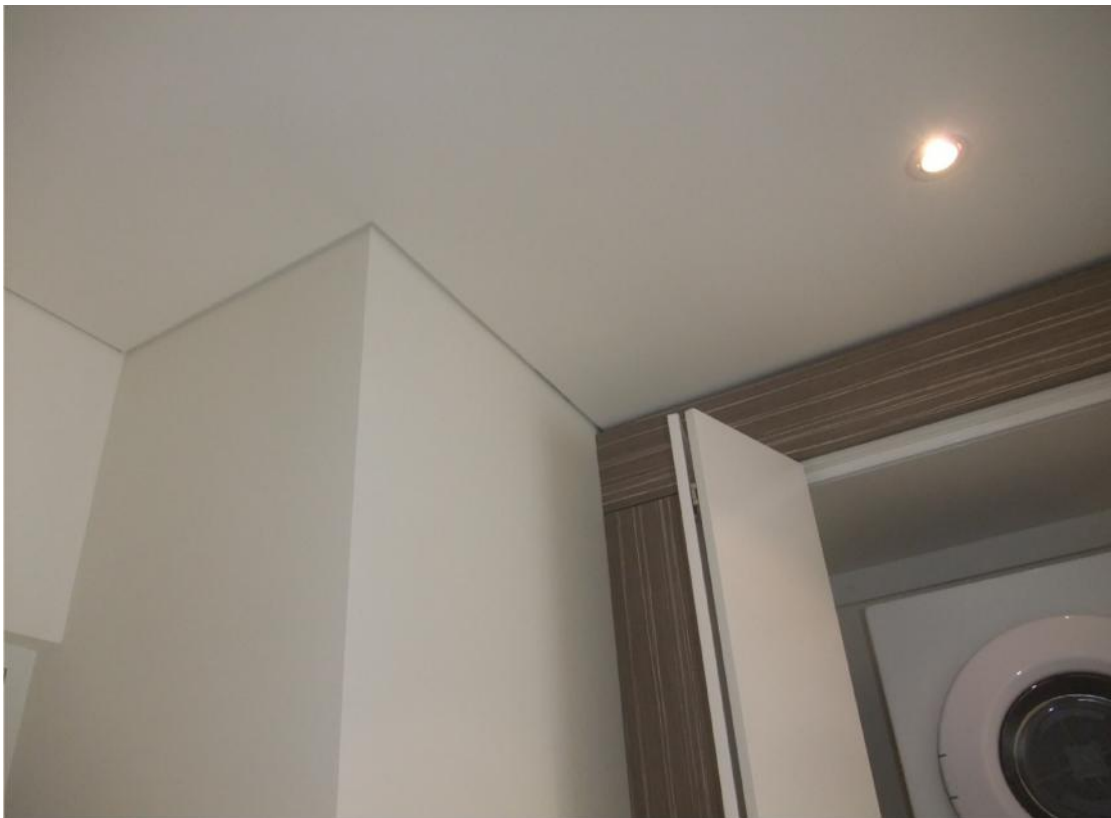
Overall Condition: Acceptable.
A small section to the ceiling near the Laundry needs re-painting.
