OWNER BUILDERS WARRANTY INSURANCE DEFECTS REPORT

[DELETED] NSW 2234

The purpose of this report was to identify visible defects to the dwelling at 207 Fowler Rd, Illawong NSW 2234.

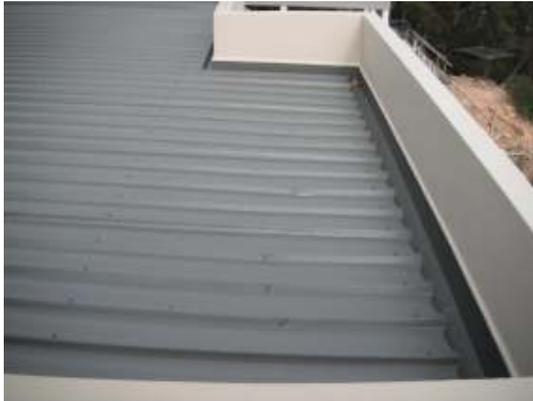
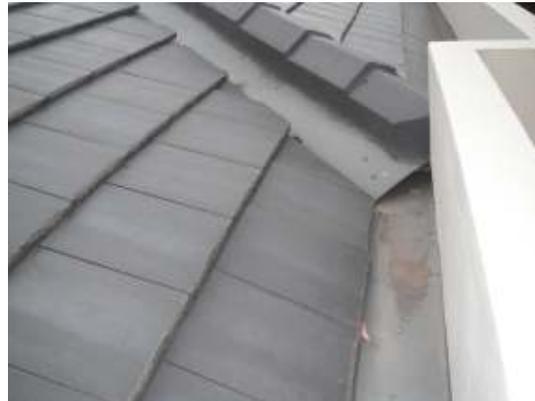
There are some dents to the metal deck roofing that in my opinion are post building and would be classed as wear and tear as the roofs are accessible from the patios.

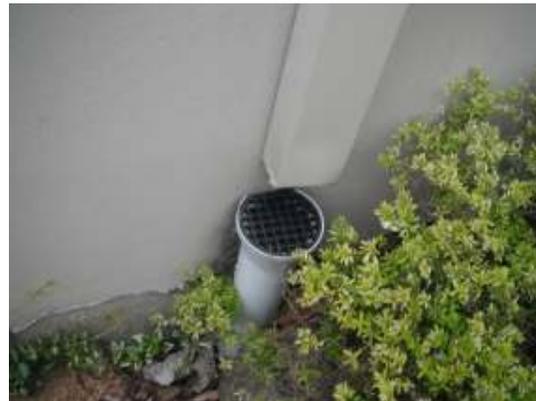
There is an air break between the downpipes and the stormwater point which is unusual. I am not a plumber and can't indicate if this is compliant but it appears that it would function well.

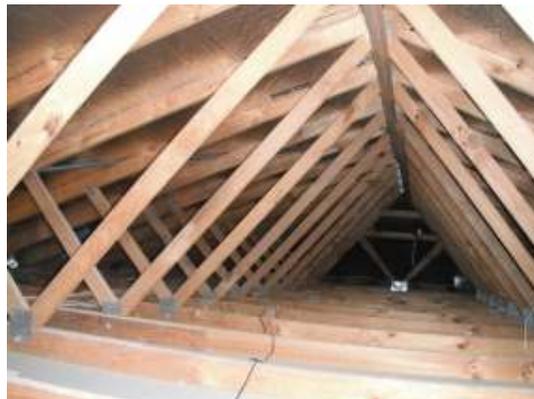
The roof framing to the pitched roof of level five is pine trusses with cement tile roofing with visible sarking fitted and no ceiling insulation.

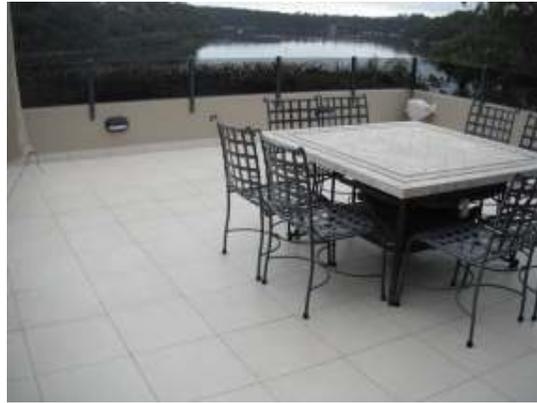
Tiled floors to levels two, three and five patios are acceptable with suitable drain points fitted.

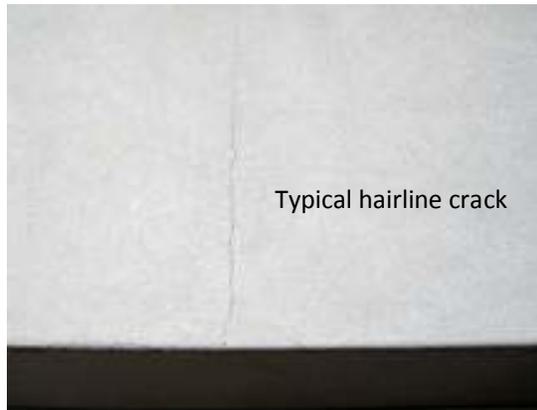
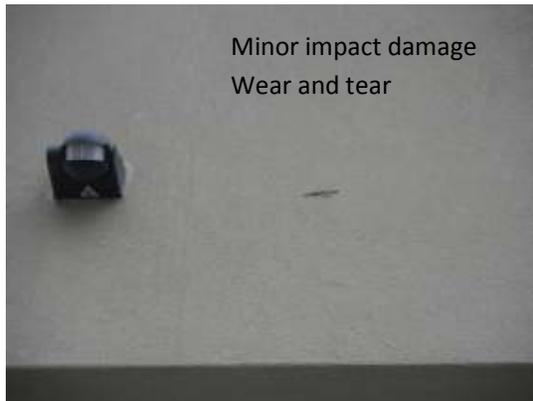
Granosite type finish rendered external walls are acceptable with suitable expansion joints created. There are a small amount of visible hair line cracks to the finish that are normal shrinkage and I would class as damage category 0, Hairline cracks. These are appearance cracks that do not need repair. There is a minor impact damage point above the main garage entry which is wear and tear.

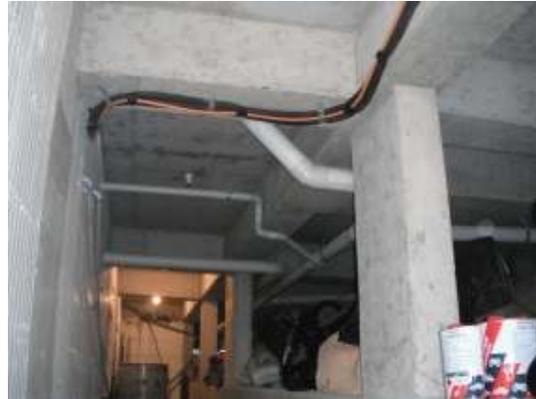
Terraced concrete floor slabs. The only area access is the service area behind the level four bathrooms.

This area was dry and appeared well drained.

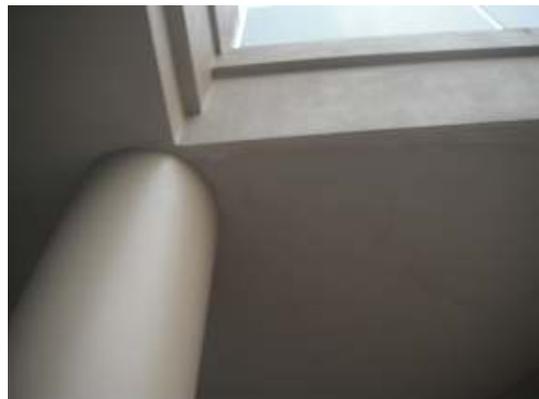
The slab soffit of level 2 over the pool has no drip groove and staining to the soffit finish is evident.

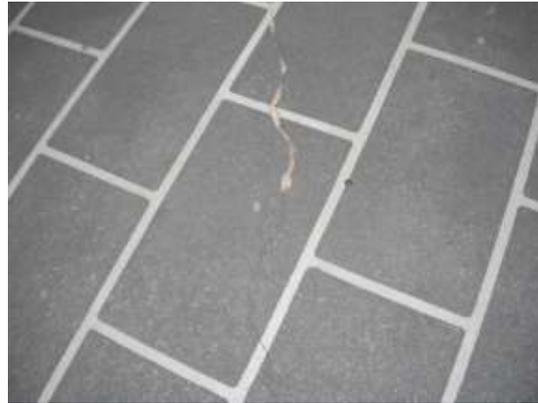
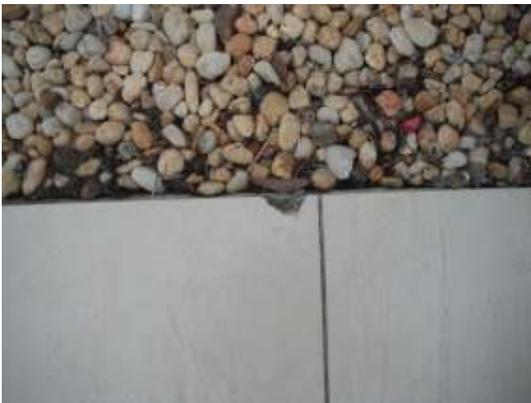
The front drive is stencilled concrete and there are some minor cracks that are damage category 0 and do not require repair. There is minor damage to the stencil finish to a crack on the east side of the driveway that is most likely normal wear and tear. The driveway was only assessed to the line of the property boundary and the common driveway was not assessed.

Paving to level two has damage to the south side at the western end, this is in my opinion is impact damage and is normal wear and tear during occupation.

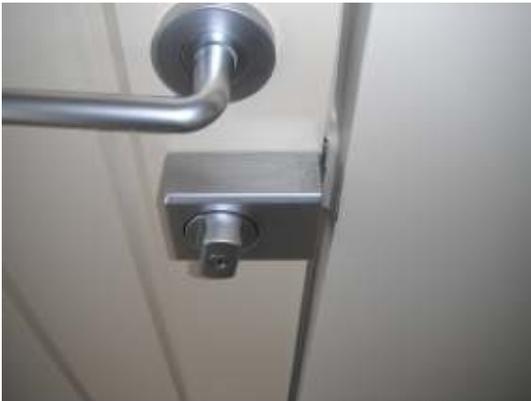
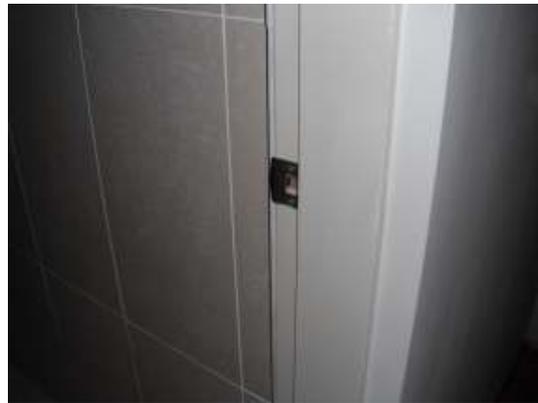
The latchset to the bathroom door of level four does not catch.

The personnel door to the main garage is binding on the jamb and minor maintenance is required.

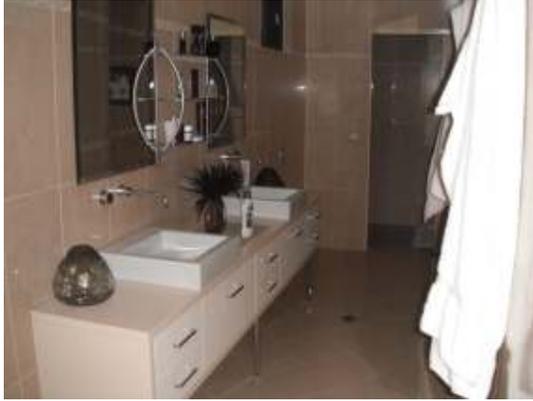
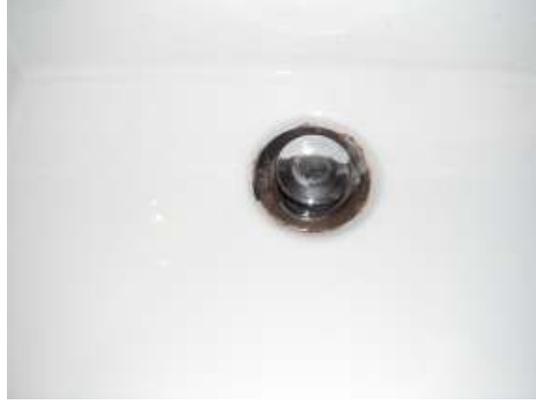
There is corrosion damage to the waste of the right hand vanity.

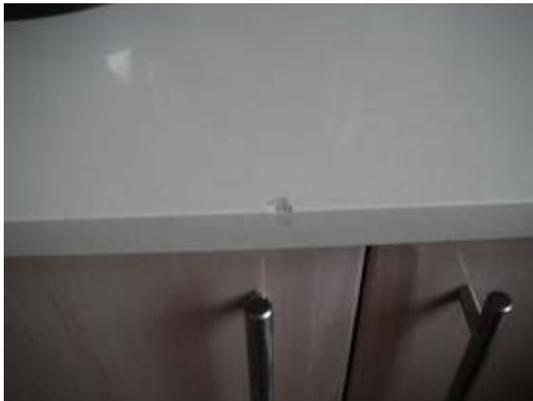
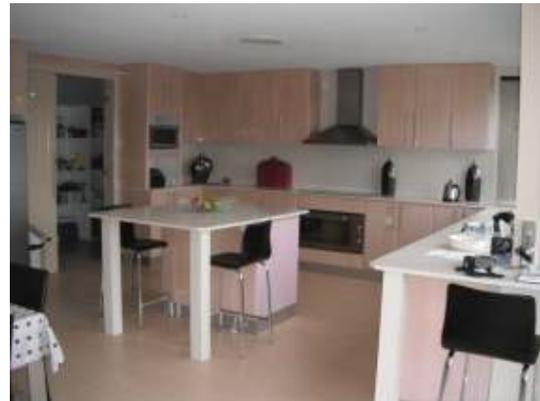
There is some wear and tear damage evident to the bench top.

Taps were run and appear to work acceptably. There was a noticeable leak at the tap body when used.

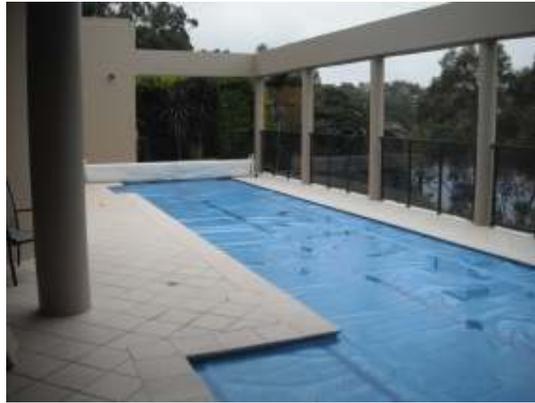
The change room / shower room was acceptable.

The fencing requirements should be referred to council to assess compliance with recent retrospective regulation changes.
